ENGINEERING MECHANICS RESEARCH LABORATORY
THE UNIVERSITY OF TEXAS AUSTIN, TEXAS

GROUND IMPACT SHOCK MITIGATION
CARGO TRUCK, 3/4-TON M37

U. S. ARMY NATICK LABORATORIES
AIRDROP ENGINEERING DIVISION

December 12, 1966

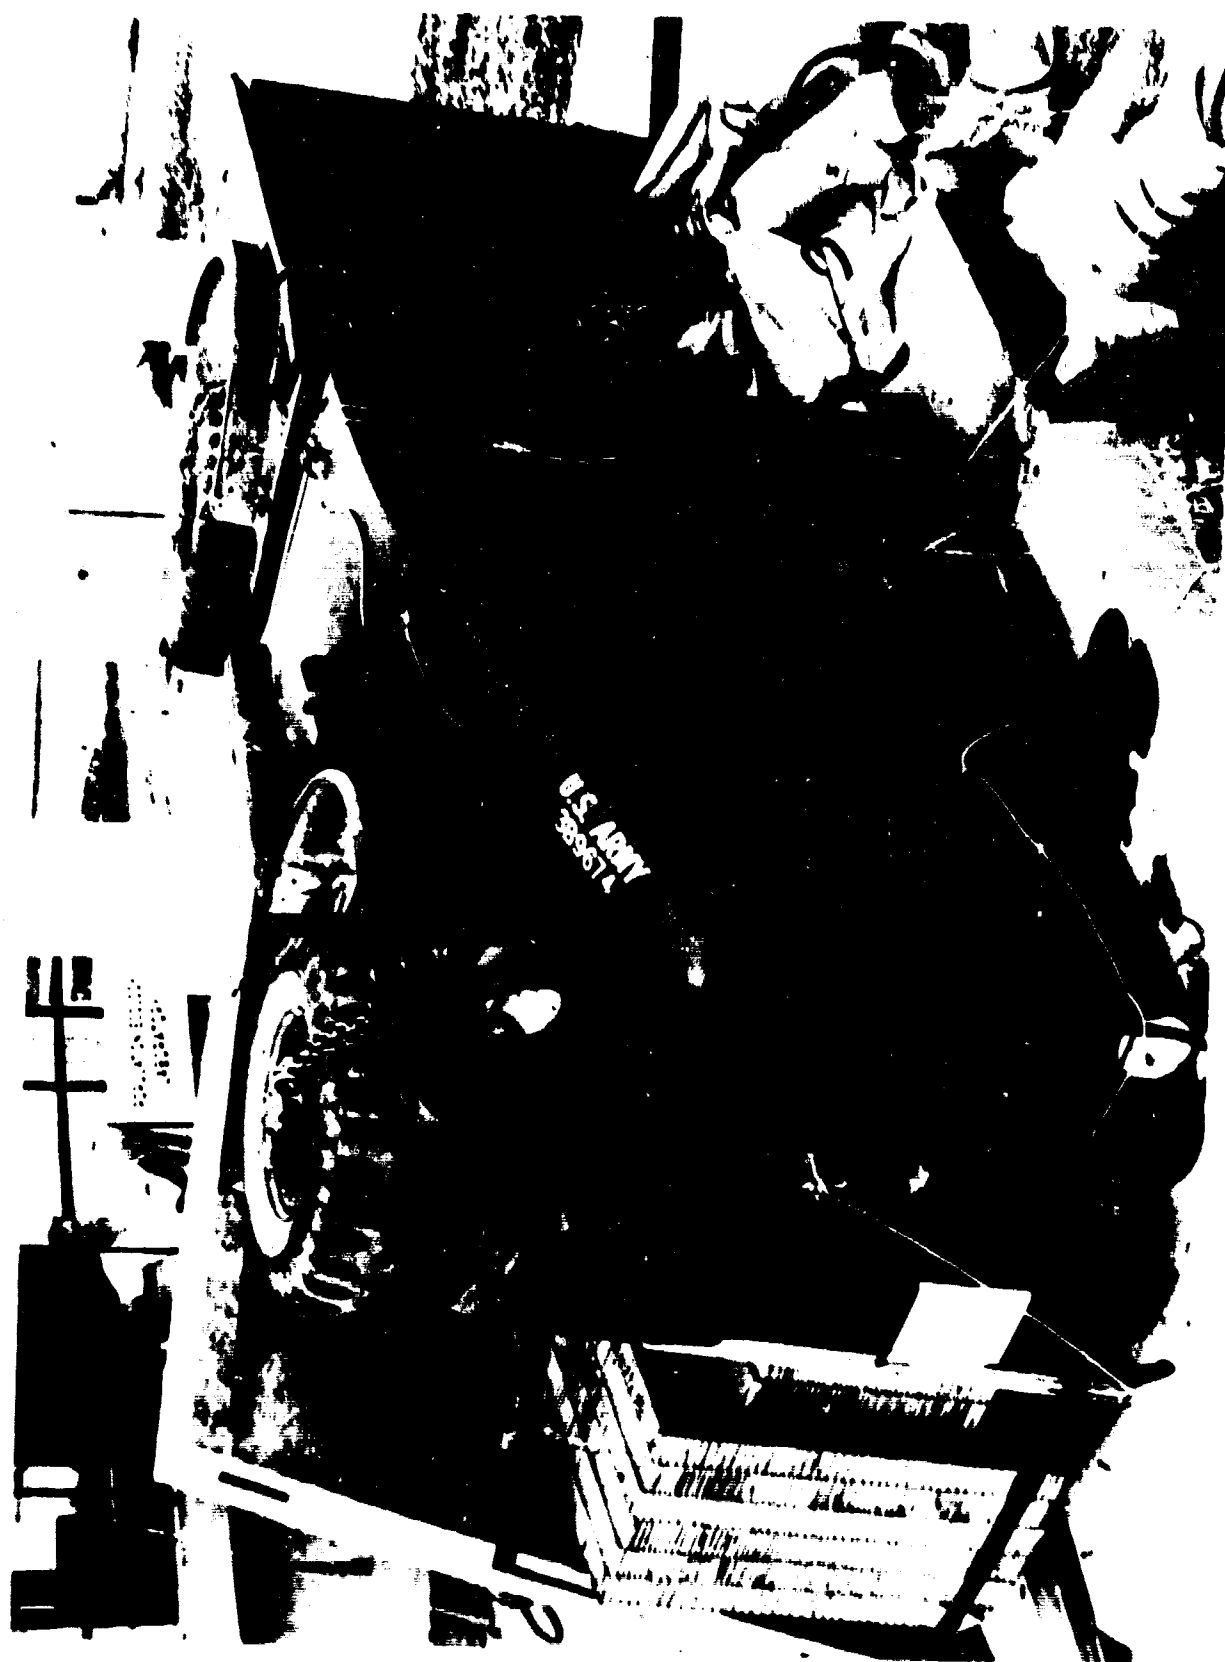
Fig. 2 Truck After Drop M37-0

As related previously, the sling system with 1/4-in. wire ropes was designed for a safety factor of two. During final preparation for the drop when the truck was being raised, the Varidrive motor and hoisting winch stalled when the truck was 9 ft above the concrete slab. As the winch was being restarted, the left rear sling cable broke, forcing the left front and right rear cables to take all the load. These two immediately broke as did the right front a moment later, and the truck and platform fell. The left rear of the system hit first, the platform split longitudinally, and the truck came to rest on its left side as seen in Fig. 2. Very little crushing of cushioning pads occurred.

1. The grease shield on the crankshaft pulley was bent so as to rub on the front motor mount cross member.
2. The front left and right rear fenders were slightly dented where the cables wrapped around the truck during the fall.
3. The left rear wheel was slightly bent.

Once the grease shield was removed from the truck and the left rear wheel replaced with the spare, the truck operated satisfactorily.

The cables were inspected for flaws and tested for strength, but nothing was found that would indicate the cables were at fault nor was anything else in the system found to be at fault. The apparent reason for the cable failure was the uneven loading in the cable strands in the region of the rigging standoffs. For subsequent drops, cable size was increased to 3/8-in. to provide a safety factor of four.
